## 2003 AHERA ASBESTOS MANAGEMENT REPORT

**Heidelberg District  
Mannheim American High School  
Mannheim-Kaefertal, Germany**

**2003 AHERA Inspection Report**

**Mannheim American High School  
Mannheim-Kaefertal, Germany  
HE 3411**

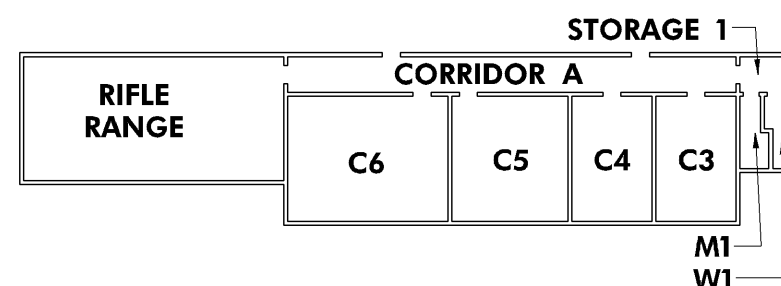
## BUILDING 0746 – MEZZANINE PLAN

MEZZANINE

STAIRWAY 1

In Building 0746, the previous AHERA inspection identified five ACM: two types of vinyl floor tile (Material Numbers 003 and 008), fire door lining (Material Number 053), cement wall panels (Material Number 055), and floor adhesive (Material Number 070). All of the previously identified ACM were located, assessed, and their quantities were confirmed. Thirteen square feet of one type of vinyl floor tile (Material Number 003) and six square feet of the other vinyl floor tile (Material Number 008) are damaged and need to be repaired. The Baker field team identified and sampled three additional suspect asbestos materials: floor adhesive (Material Number 146), sheet gasket (Material Number 147), and caulk (Material Number 148). The caulk (Material Number 148) tested positive for asbestos. Both of the other newly sampled materials tested negative for asbestos.

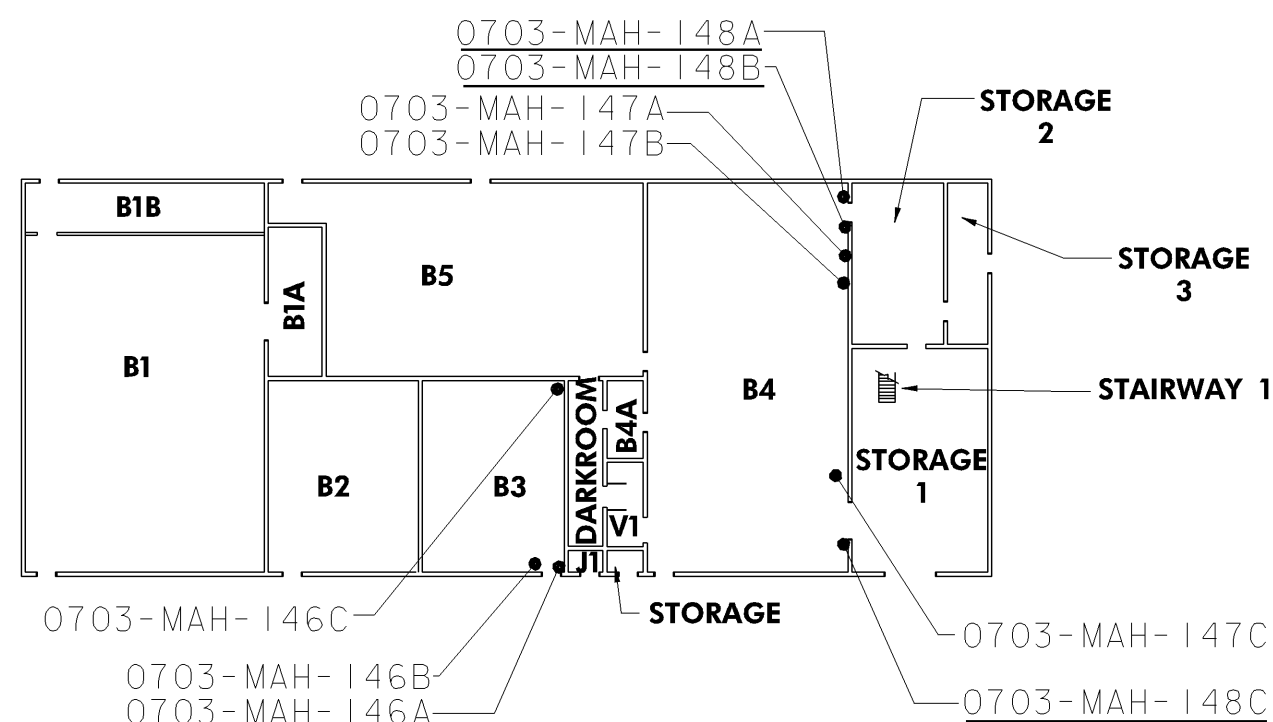
## BUILDING 0746 – FIRST FLOOR PLAN

NOTE:  
ONLY SAMPLES TAKEN  
DURING THE AHERA  
INSPECTION ARE SHOWN.
